The Kona Earthquake of August 21, 1951, and Its Aftershocks¹

GORDON A. MACDONALD and CHESTER K. WENTWORTH²

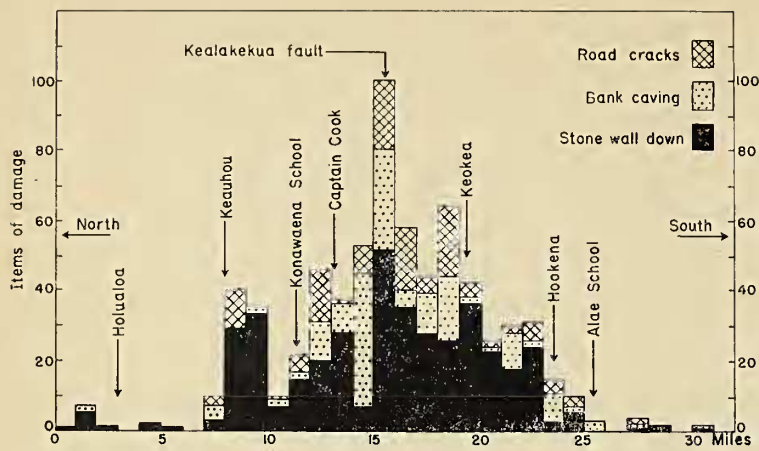
FIG. 3. Diagram showing the frequency distribution of three of the principal types of earthquake damage along the main highway. The arrows indicate the position on the highway of some villages and other features. Note the centering of damage close to the Kealakekua fault.

The distribution of abundance of rock slides in road cuts is shown in Figure 3, in which it is represented by the portion of the columns labeled "bank caving." Like the other damage shown in the graph, it was greatest in the immediate vicinity of the Kealakekua fault, inland from and a little south of Kealakekua Bay.

Damage to paved roads was of three general sorts: (1) cracking of pavement, (2) cracking and slumping of shoulders and separation of shoulders from pavement, and (3) collapse of road cuts, causing partial obstruction of the road. The latter has already been discussed under the heading "Rock Slides." Minor cracking of shoulders occurred over an area extending about 10 miles north and 12 miles south of the approximate epicenter, and a few cracks were formed as far away as the northeast side of Kilauea Caldera, 47 miles from the epicenter. However, extensive pavement cracking and slumping were restricted to the area between Captain Cook and Hookena. The distribution of cracks in the road is shown in Figure 3.

of the epicenter can be derived from the study of damage by the earthquake. The general distribution of damage to roads, stone walls, and road cuts along the main highway is shown in Figure 3. This is based on a count checked against odometer mileage, assigning one unit of damage for each 1 to 15 feet of collapsed wall or road cut. Despite irregularities, the graph shows a distinctly symmetrical, bell-shaped distribution curve, with its peak about 2.5 miles by road southeast of Captain Cook. An average of more than 60 items of damage per mile in the central 5 miles decreases to only one or two per mile more than 9 miles from the center. This point of maximum damage coincides closely with the position of the buried inland extension of the Kealakekua fault. Other types of damage also were most abundant in the same general area. Together with the fact that most of the aftershocks, located by instrumental means, originated on the Kealakekua fault, it leaves little question that the origin of the major earthquake lay on or close to this fault, and that the earthquake almost certainly resulted from movement on it.

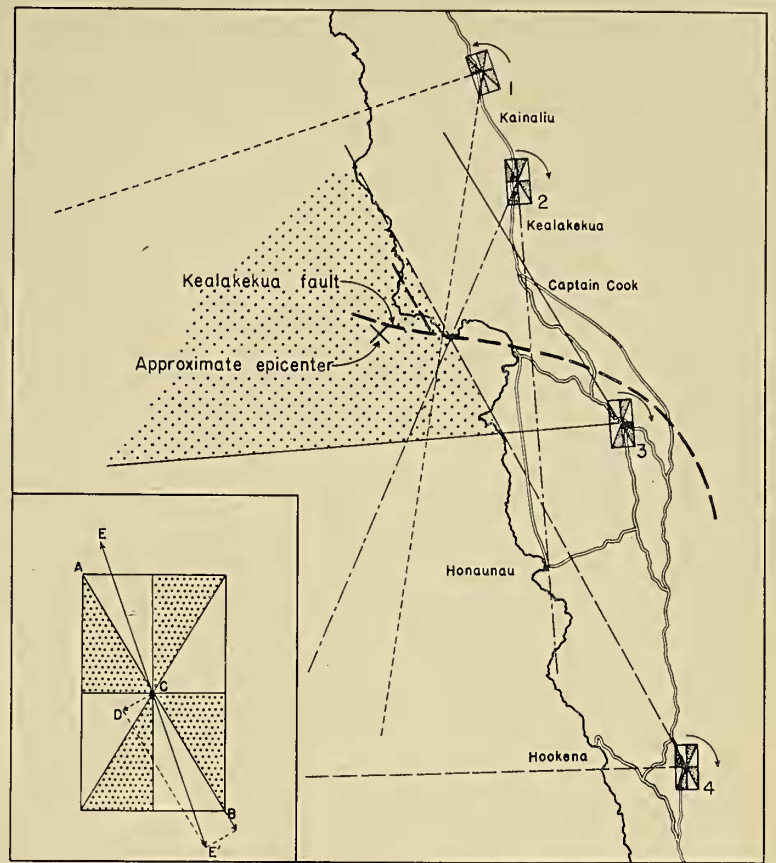
FIG. 12. Map of the central Kona area, showing the prevalent direction of rotation of monuments in cemeteries. The cemeteries are: 1, Daifukuji, Honalo; 2, Hongwanji Mission, Kealakekua; 3, Hongwanji Mission, Keei; 4, Kalahiki Japanese. At each cemetery the arrow indicates the prevalent direction of rotation. The boundaries of the octants containing the direction toward the epicenter are prolonged. The stippled area west of Captain Cook is that in which three or more of the octants overlap. The inset in the lower left is a diagram (after Imamura, 1937) of a horizontal cross section of a rectangular column, indicating the manner in which horizontal earthquake motion E—E' causes rotation of the column.

In Figure 12 the prevalent directions of rotation of monuments in four cemeteries are shown. Four other cemeteries were omitted because no monuments were rotated in them, or because the number of rotated monuments was too small to yield a reliable statistical result. At each of the four cemeteries plotted, the boundaries of the octants containing the direction toward the epicenter are prolonged. In an area largely west of the shoreline, from 2 miles south to 2 miles north of the approximate trace of the Kealakekua fault, three or more of the four significant octants overlap, and it is within this area of overlap that the epicenter should be situated.

It has already been pointed out that the prevalent direction of rotation of columns in cemeteries indicates a location of the epicenter within the shaded offshore area in Figure 12. This area contains the seaward extension of the Kealakekua fault.
